Carbon footprint repairing versus replacing of window frames

Public report

Publicationnumber: 23.210382.005

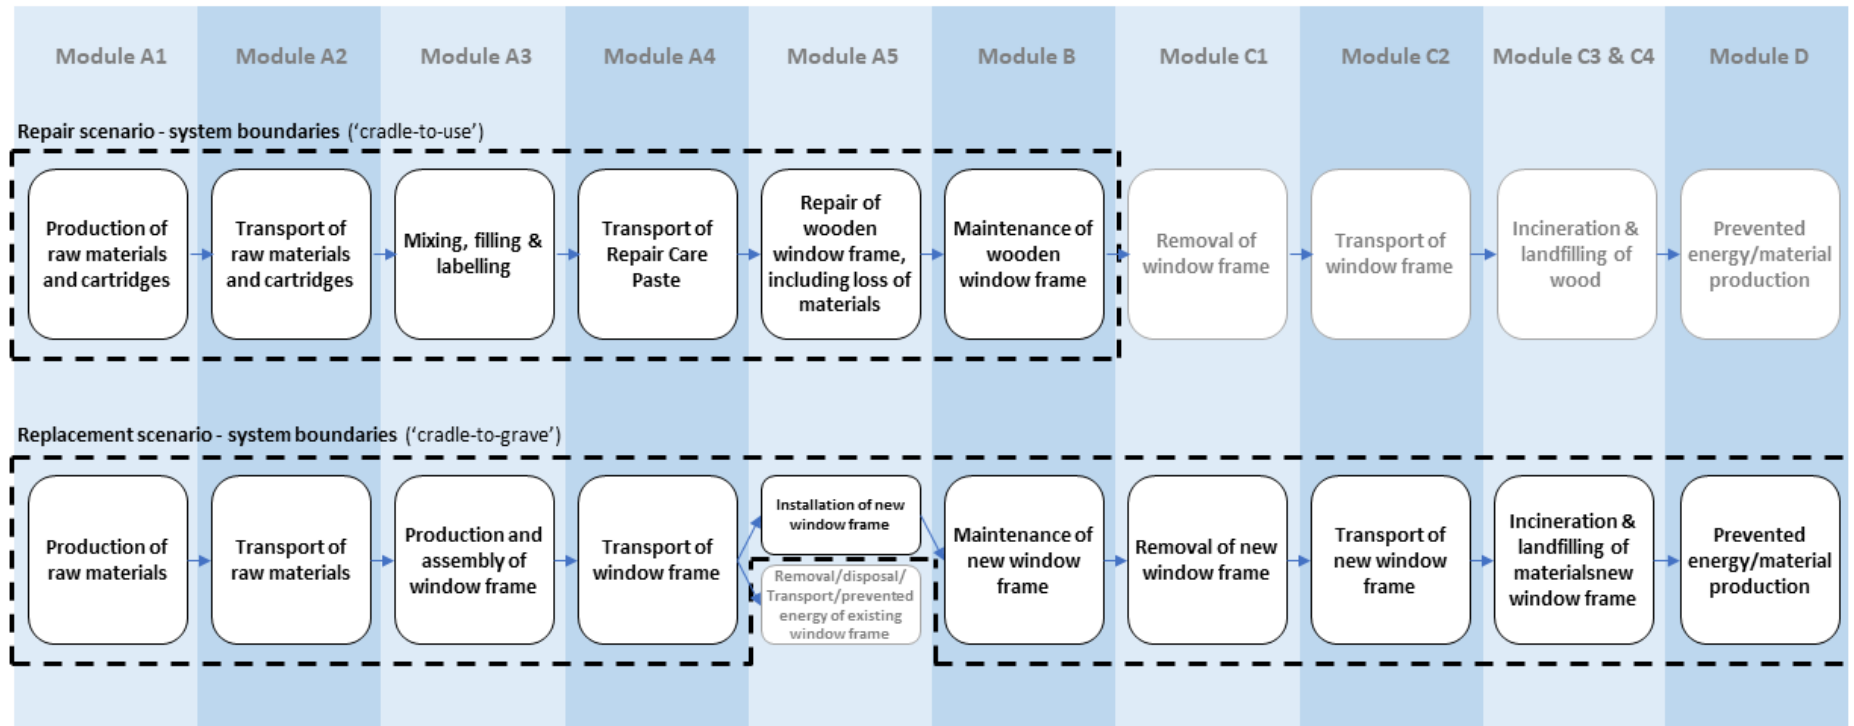
Figure 9 - System boundaries of the repair & replacement scenarios (EN15804 modules indicated)*

* The omitted life cycle stages (Module C1-D in the repair scenario and part of Module A5 in the replacement scenario) are identical: they encompass the waste disposal of the damaged wooden window frame.

The life cycle stages within the system boundaries are presented in Figure 9 on the next page. We explain the system boundary choices below the figure.

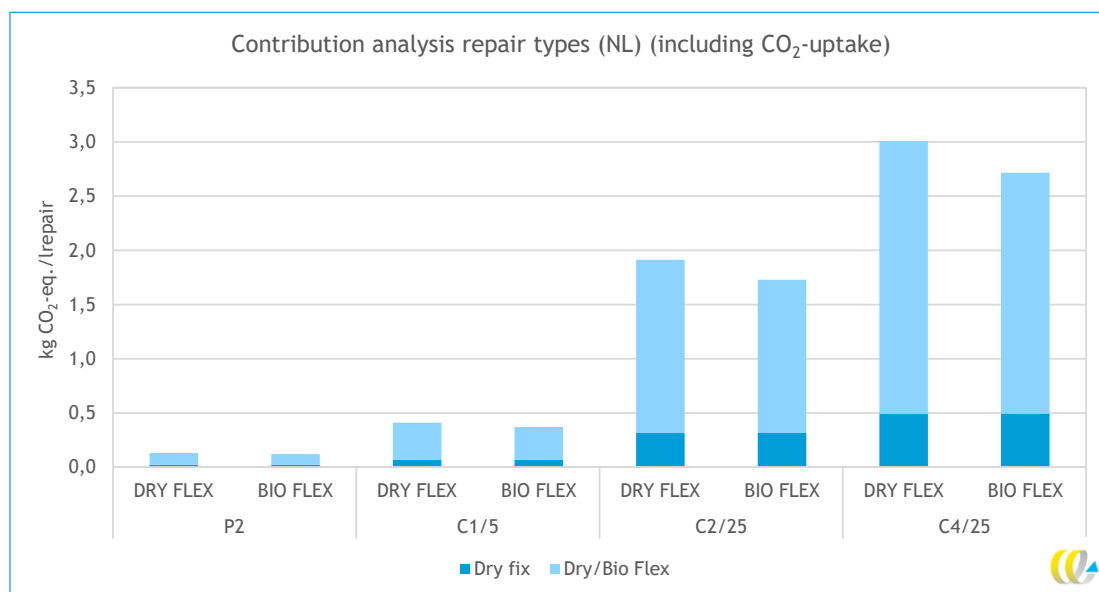
Figure 12 - Contribution analysis repair types, per applied Repair Care product (Module A1-A5, including benefit biogenic carbon content)

Because a repair involves both the primer and the repair resins, the contribution of the repair resins (DRY FLEX® 4 AND DRY FLEX® ALLROUND) and primer (DRY FIX® UNI) can be found in Figure 11 and Figure 12 per repair type. Again a distinction is made between results excluding and including the benefit of biogenic carbon content.

The carbon footprint increases with the severity of the repair from P2 to C4/25. The carbon footprint of repairs carried out with BIO FLEX™ ALLROUND is slightly lower (3%) than the carbon footprint of repairs carried out with DRY FLEX® 4. When the benefit of biogenic carbon content is taken into account, the carbon footprint of repairs with BIO FLEX™ ALLROUND is 10% lower. This difference might be associated with uncertainties in the background data, however, which we investigate further in Section 3.4.1. For all repairs (ex- and including the benefit of the biogenic carbon content), the repair resins contribute around 84% to the total carbon footprint per repair, while the remaining 16% can be attributed to DRY FIX® UNI.

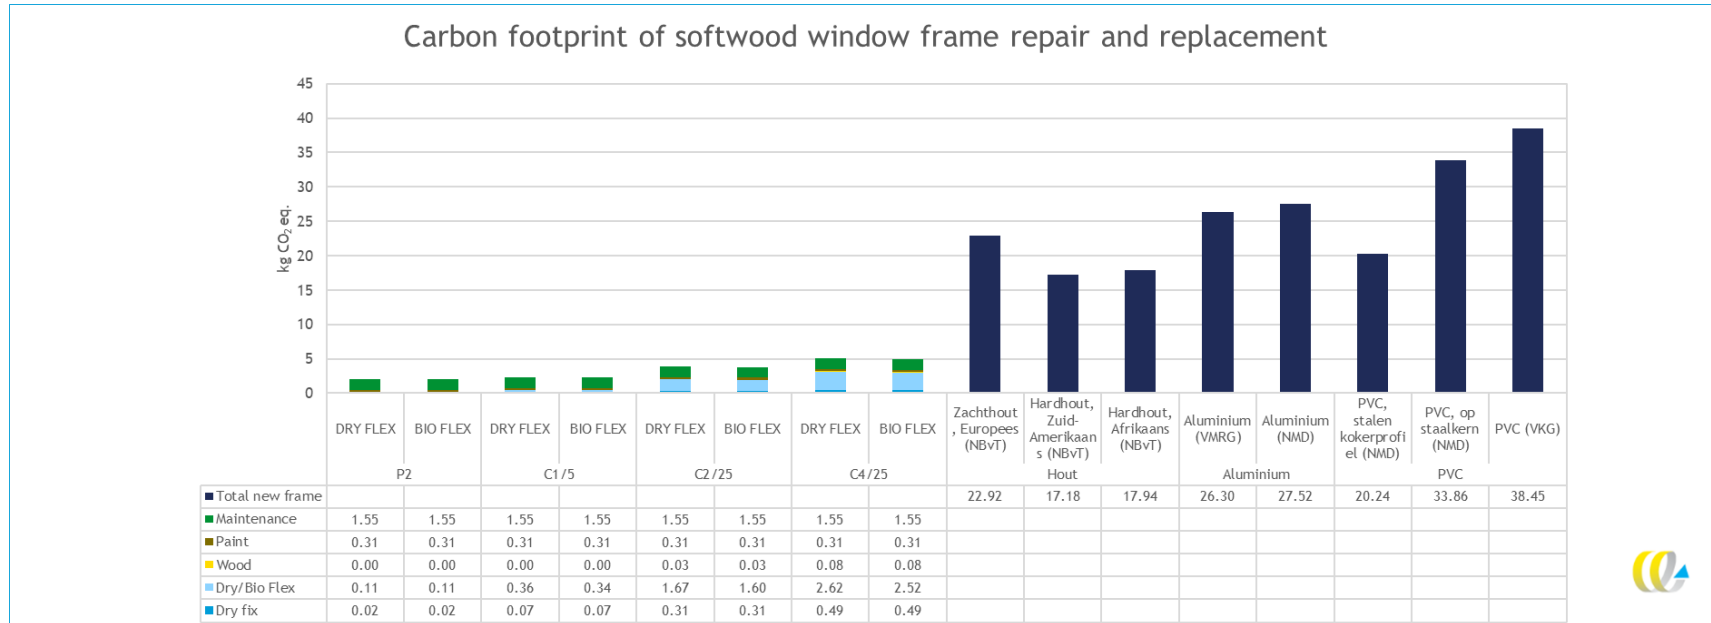
Figure 14 - Carbon footprint of *softwood* window frame repair and replacement, entire life cycle (Module A1-D, during 25 years, excluding waste disposal of original repaired/replaced wooden frame, *excluding* benefit biogenic carbon content)

The comparison between window repair and replacement is presented in Figure 13 for a damaged window frame from hardwood (lifetime: 75 years) and in Figure 14 for a damaged window frame from softwood (lifetime: 25 years). As this difference caused by the benefit of biogenic carbon content is only minor in comparison to the replacement scenarios, we present the comparison between the repair and replacement scenarios only with the results excluding the benefit of biogenic carbon content.

When comparing the repair scenarios with the replacement scenarios, repairing the window frame results in a significantly lower carbon footprint in all cases. This is the case for both damaged window frames made from softwood and from hardwood. Both figures do not include the benefit of biogenic carbon content, which would entail a slightly decreased carbon footprint for all repair scenarios (0-5%).

The difference in the carbon footprint of the repair and replacement scenarios between Figure 13 and Figure 14 is caused by the differing lifetime of the window frames (25 or 75 years). For the repair scenarios more extensive maintenance is required during 75 years than 25 years (see Section 2.5). For the replacement scenarios we take the entire lifetime of the window frames into account, which means three window frames of softwood (lifetime of 25 years) are required compared to one window frame of hardwood, aluminium or PVC (lifetime of 75 years). Reversely, to compare to the window frame of softwood (lifetime 25 years) with the other window frames (lifetime 75 years), the carbon footprint of the window frames of hardwood, aluminium or PVC is divided by three, as they are only on 1/3rd of their lifetime after 25 years.

replacement of the damaged window frame (see Figure 13 and Figure 14). Even when multiple splicing repairs (C4/25) are carried out on one window frame, the carbon footprint of repair is still lower than when the damaged window frame is replaced with any of the new window frames.
